MIDLAND STANDARD ENGINEERING & TESTING, INC.

November 27, 2018

Re: Pavement Coring and Subgrade Evaluation
McHenry County College – Parking Lot E
Crystal Lake, Illinois
MSET File No. 18599

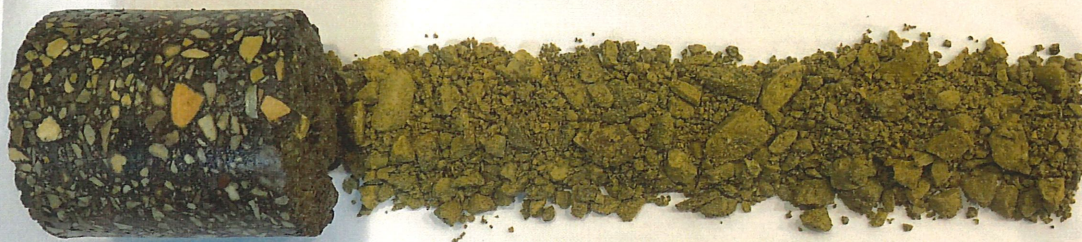
Core No. C-1						
Location	See Location Map					
Material	Depth (in.)		Thickness (in.)		Remarks/Condition	coeff sn
Bituminous Surface	0	to 2	2			0.30 0.60
Bituminous Binder	2	to 4	2			0.23 0.46
Granular Base Course	4	to 17	13		Crushed Stone	0.10 1.30
Subgrade	17				Dark Grey CLAY, A-7-6 Mc=25%, Qu=0.9 to 1.3 tsf	<u>2.36</u>
Core No. C-2						
Location	See Location Map					
Material	Depth (in.)		Thickness (in.)		Remarks/Condition	coeff sn
Bituminous Surface	0	to 1	1			0.30 0.30
Bituminous Binder	1	to 2- 1/2	1- 1/2			0.23 0.35
Granular Base Course	2- 1/2	to 11	8- 1/2		Crushed Stone	0.10 0.85
Subgrade	11				Dark Grey CLAY, A-7-6 Mc=24%, Qu=0.6 to 0.9 tsf	<u>1.50</u>
Core No. C-3						
Location	See Location Map					
Material	Depth (in.)		Thickness (in.)		Remarks/Condition	coeff sn
Bituminous Surface	0	to 1	1			0.30 0.30
Bituminous Binder	1	to 3	2			0.23 0.46
Granular Base Course	3	to 11	8		Crushed Stone	0.10 0.80

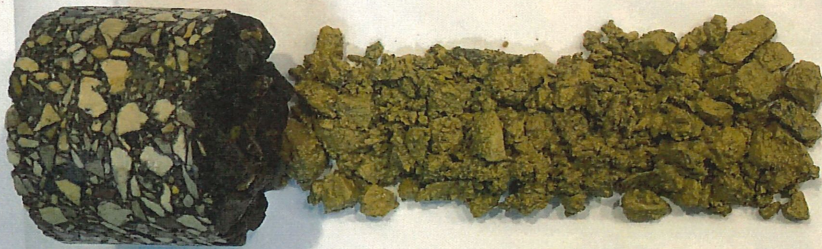
Subgrade	11				Dark Grey CLAY, A-7-6 Mc=21%, Qu=1.3 to 2.2 tsf	<u>1.56</u>
Core No. C-4						
Location	See Location Map					
Material	Depth (in.)		Thickness (in.)		Remarks/Condition	coeff sn
Bituminous Surface	0	to 1	1			0.30 0.30
Bituminous Binder	1	to 3	2			0.23 0.46
Granular Base Course	3	to 12	9		Crushed Stone	0.10 0.90
Subgrade	12				Dark Grey CLAY, A-7-6 Mc=20%, Qu=2.2 to 3.7 tsf	<u>1.66</u>

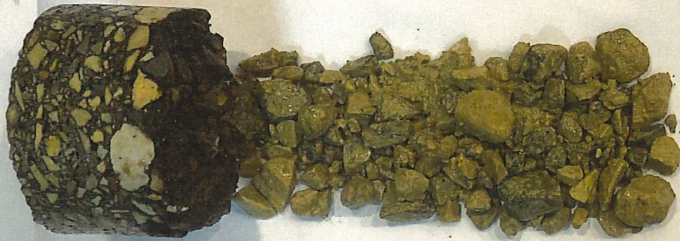
Core No. C-5						
Location	See Location Map					
Material	Depth (in.)		Thickness (in.)	Remarks/Condition	coeff	sn
Bituminous Surface	0	to 1- 1/2	1- 1/2		0.30	0.45
Bituminous Binder	1- 1/2	to 2- 1/2	1		0.23	0.23
Granular Base Course	2- 1/2	to 10	7- 1/2	Crushed Stone	0.10	0.75
Subgrade	10			Dark Brown and Dark Grey CLAY, A-7-6 Mc=25%, Qu=0.6 to 2.2 tsf		1.43
Core No. C-6						
Location	See Location Map					
Material	Depth (in.)		Thickness (in.)	Remarks/Condition	coeff	sn
Bituminous Surface	0	to 1	1		0.30	0.30
Bituminous Binder	1	to 2- 3/4	1- 3/4		0.23	0.40
Granular Base Course	2- 3/4	to 12	9- 1/4	Crushed Stone	0.10	0.93
Subgrade	12			Brown and Grey Clay LOAM, A-6 Mc=17%, Qu=2.7 to 4.2 tsf		1.63
