EXECUTIVE SUMMARY

McHENRY COUNTY COLLEGE

FACILITY CONDITION ANALYSIS

APRIL 2011

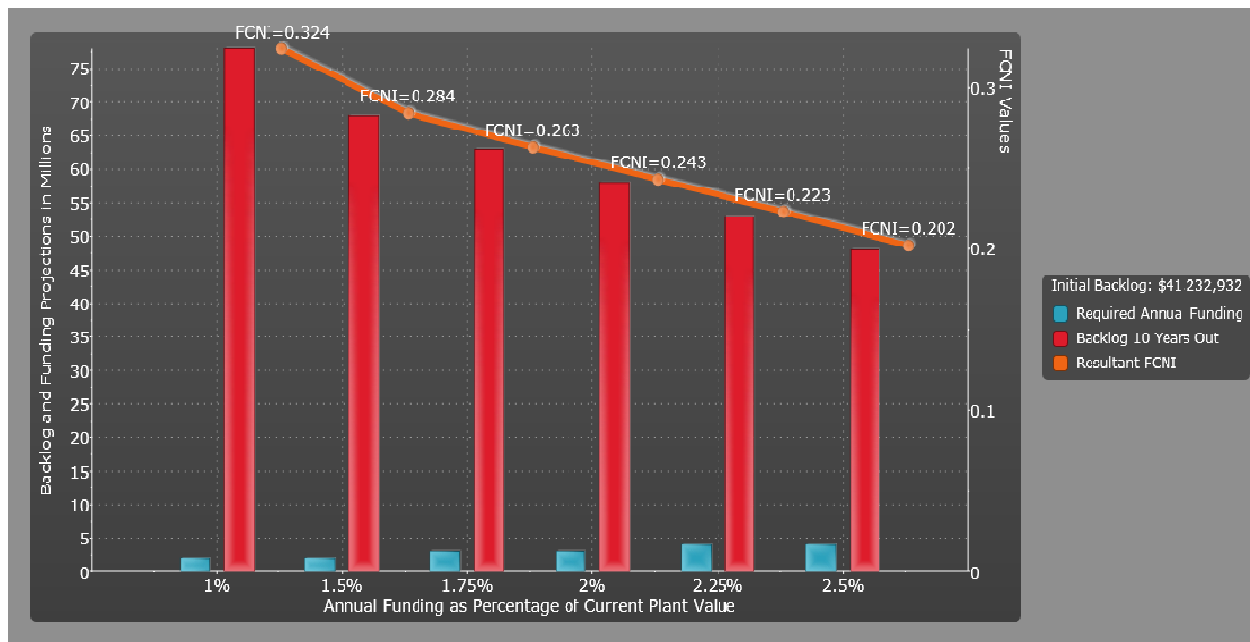
The funding model tool in the ISES AMS database calculates that the status quo FCNI of 0.26 can be maintained by reinvesting at the rate of 1.75 percent of current plant value (\$2.83 million annually). The figure is an annuity and accounts for inflation. The chart below shows the projected FCNI and backlog (after ten years) resulting from the reinvestment of various percentages of current Plant Value.

The model also considers the rates at which the portfolio will grow, the project backlog will grow due to maintenance deferral, and new project backlog will crop up. If the future reinvestment rate is lower than 1.75 percent of plant value, the FCNI will gradually increase over the next ten years. For example, a 1 percent reinvestment rate (\$1.61 million annually), will cause the portfolio-wide FCNI to increase or worsen to 0.32 at the end of ten years. Reinvestment at the rate of 2.5% of plant value (\$4.04 million annually), will cause the portfolio-wide FCNI to decrease or improve to 0.20 at the end of ten years.

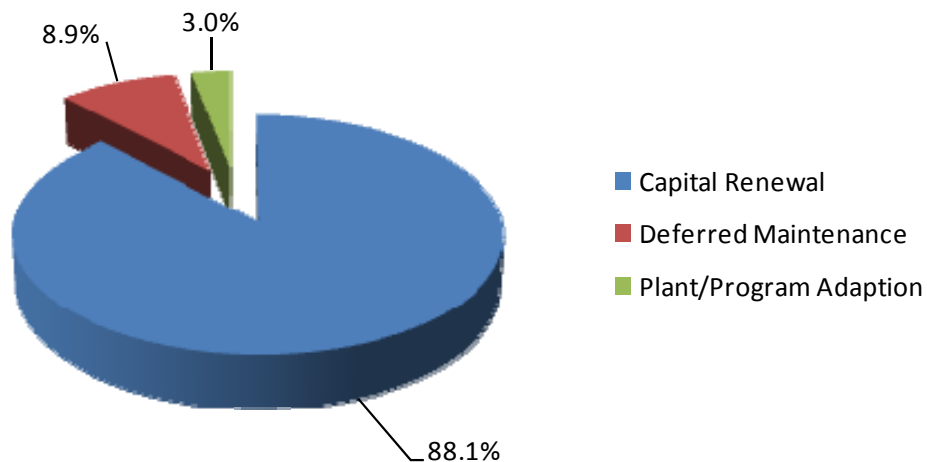
2.5 Figure 5 – Project Classification Project Cost Distribution Chart

In the chart above, we can see that 3.0 percent of the project backlog falls within the Adaption Projects classification. This classification typically consists of accessibility and life / safety projects. Consisting almost entirely of fire / life safety upgrades, MCC is better than the historical average of other clients in this project classification. This is largely due to the existence and acceptable installation of the fire / life safety systems and accessibility improvements within the MCC portfolio.

The proportion of Capital Renewal projects to Deferred Maintenance projects at MCC is greater than that of past ISES clientele. This indicates that, while diligent maintenance efforts are keeping them operational, a significant number of original systems have reached their statistical life cycles and need to be replaced.
